**EFFECT OF AN ELEVATED TEMPERATURE  
HIGH HUMIDITY ENVIRONMENT ON  
SCOTCH NO. 425 ALUMINUM TAPE.**

D. ROBERT ASKINS  
UNIVERSITY OF DAYTON RESEARCH INSTITUTE  
DAYTON, OHIO 45469

TECHNICAL REPORT AFML-TR-78-14  
Interim Technical Report November 1976 - October 1977

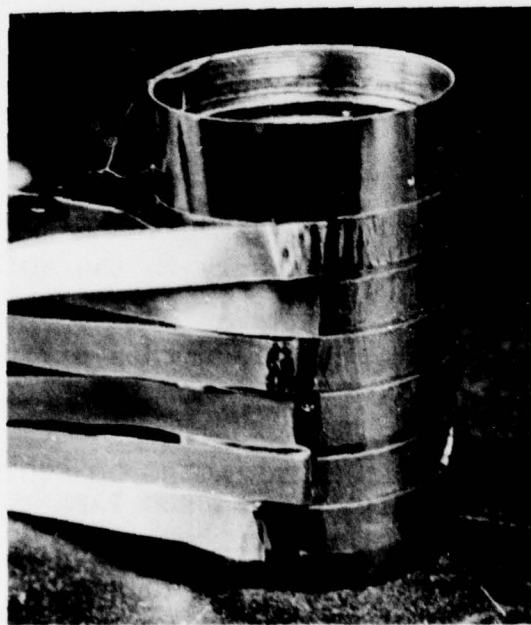
(a) Control Specimen - Three Strips of Tape

(b) Specimen For Environmental Exposure - Three Strips to Be Tested After 60 Days and Three After 120 Days Exposure

Figure 2. Fuse Body Peel Specimens.

One of these two, for each type surface plate, was used for unaged control peel tests and the other for peel tests after aging for either 60 or 120 days. Adhesive tape strips 1.27 cm (one-half inch) wide by about 50.8 cm (20 inches) long were applied circumferentially around the fuse bodies (three strips on the control and six strips on the body to be aged - see Figure 2). An 8.25 cm (3.25 inch) diameter rubber covered steel roller was used to roll the tape onto the fuse body. The adhered tape extended nearly completely around the fuse body (Figure 2).

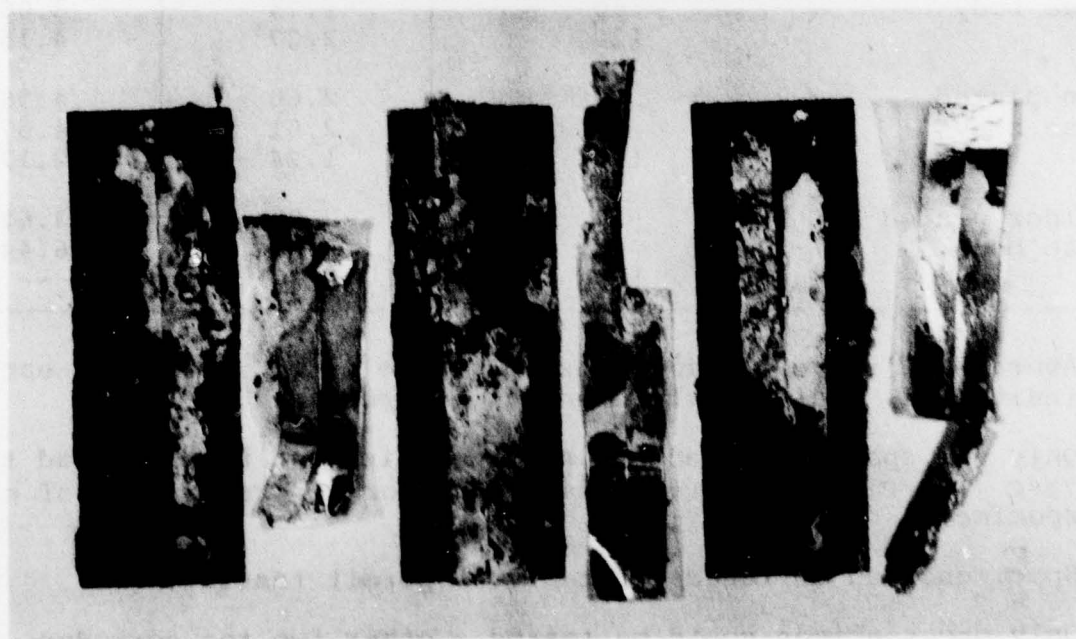
(a) 60 days aging

(b) 120 days aging

Figure 4. Appearance of Flat 1018 Steel Peel Panels After Aging at 71°C(160°F) and 75% R.H.

The results obtained for all of the peel tests conducted during this program, including that one just described, are presented in Table 3. Figures 4 and 5 illustrate the appearance of the 1018 steel flat panels and the plated fuse body specimens after the 60 and 120 day aging periods. The 6061T6 aluminum flat panels are not illustrated because no evidence of corrosion damage was present on these specimens after aging. Inspection of Table 3 and Figures 4 and 5 leads to several significant observations.

The environmental aging at 71°C (160°F) and 75 percent R.H. produced severe corrosion on the 1018 steel substrate panels. After 60 days, corrosion was visibly evident and peel strength had fallen 10 percent. After 120 days, corrosion was severe and the specimens could not even be tested.

It is evident in Figures 4 and 5 that salt deposits are present on the test specimens. A sodium chloride solution was used to obtain the 75 percent R.H. environment, and even though the test specimens were never in direct contact with the liquid solution in the aging tanks, it is obvious that some of the electrolyte did deposit upon the samples. The presence of this corrosive media on the samples no doubt contributed to the corrosion which occurred. Since the aluminum foil tape was galvanically dissimilar to all of the substrates to which it was

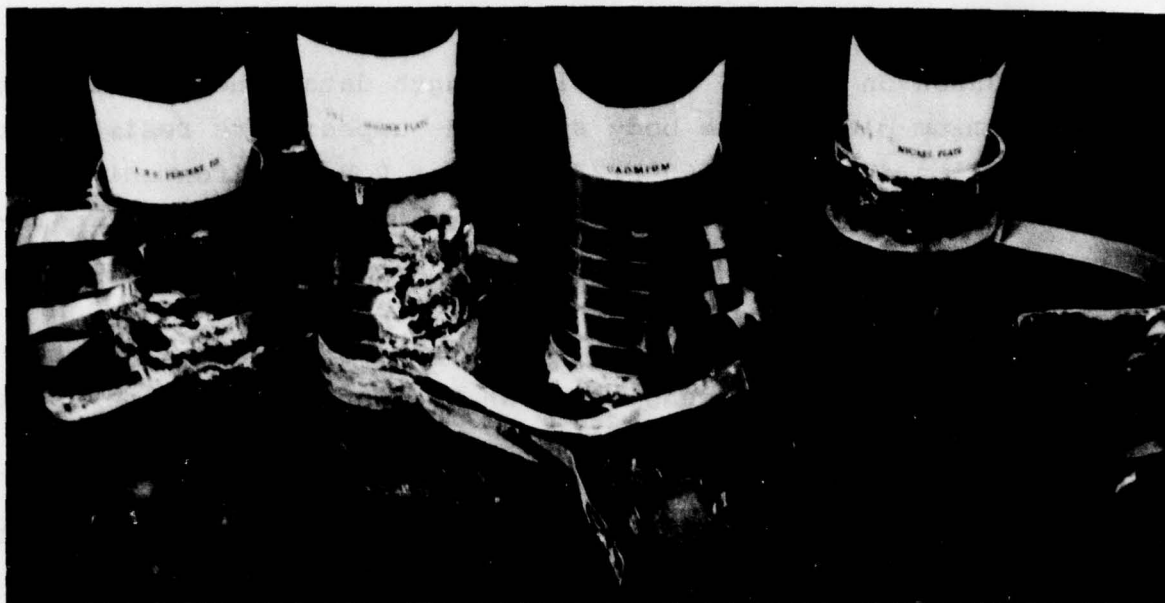
(a) 60 days aging

(b) 120 days aging

Figure 5. Appearance of Plated Fuse Body Specimens After Aging at 71°C(160°F) and 75% R.H.

The results on the four different types of plated fuse bodies is somewhat more difficult to interpret. On three types of plating (cadmium, tin, and solder) the peel strength was higher after 60 days aging than on the original unaged specimens, but after 120 days on these three types, the peel strength was either lower than the original or could not be tested due to excessive corrosion of the unbonded tape gripping tabs. On the fourth type of plating (nickel) the peel strength was lower after
